SERVICE BULLETIN

No. B946466-1.0 P/N B946466 Beede Tachometer Service Bulletin

Reason: Tachometer needle is stuck at 4000RPM

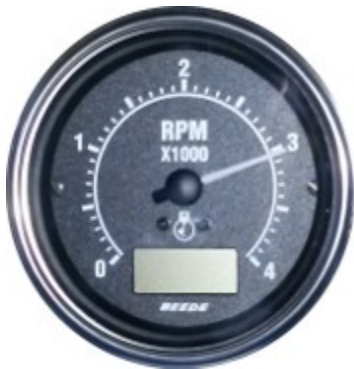
- The tachometer needle may become stuck on the 4000RPM stop pin
- This is usually caused by the engine being turned off above 2000RPM.(ex. Emergency shut down)

Typical needle location after emergency shut down.

1. First, verify power and ground are connected, and that the signal wire is connected to the signal source.
2. Next, start the engine and increase the RPM to approximately 2500RPM or until the needle comes back to the correct RPM.
3. Then, decrease the engine RPM to idle and turn ignition off.
4. The tachometer will operate correctly afterward.

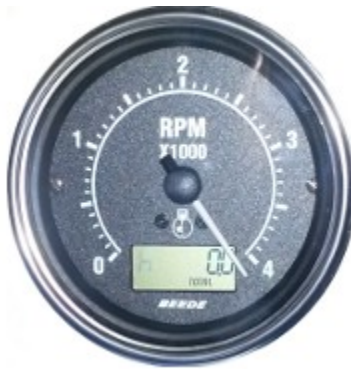
Appearance at stuck position after emergency shut down & ignition is turned back on.

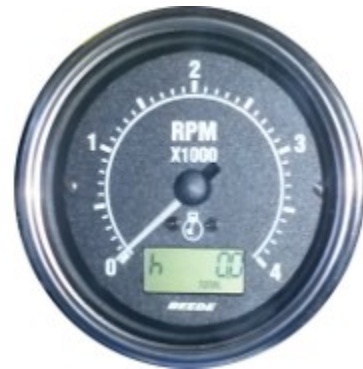
Proper needle location when ignition is on. After corrective measures.
